Field Study Photographs for Historic Preservation

The Privy at Körner's Folly, Kernersville, N.C.
February 15, 2003

James C. Burke

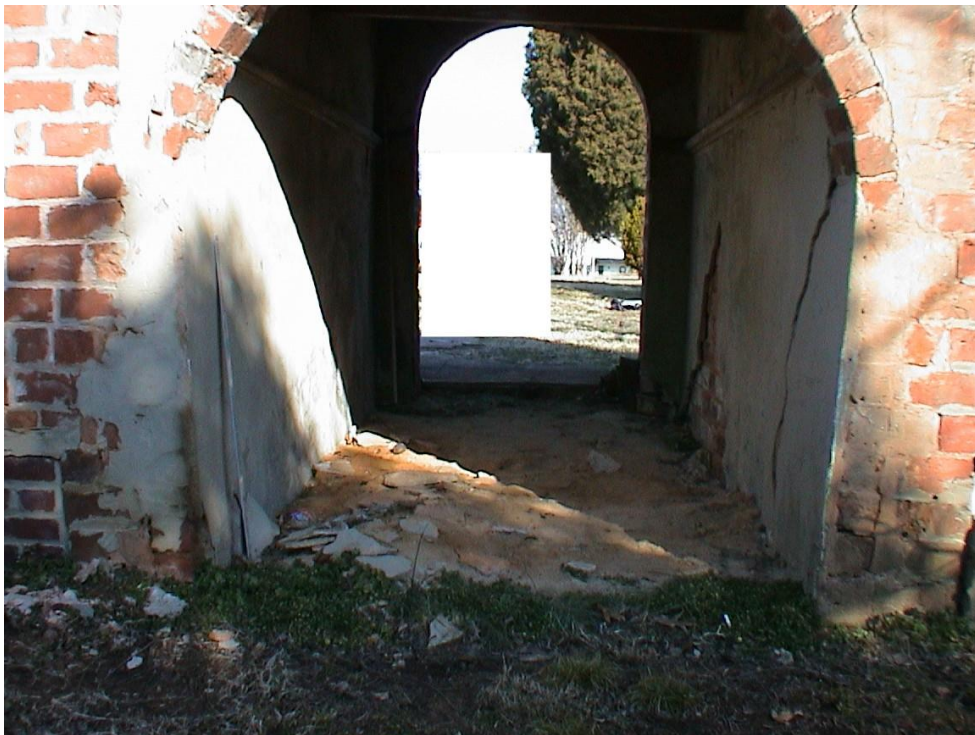
Figure 19

Rear of the privy

Structural failure

Failing mortar joints

Problem related to the use of Portland cement in earlier repointing

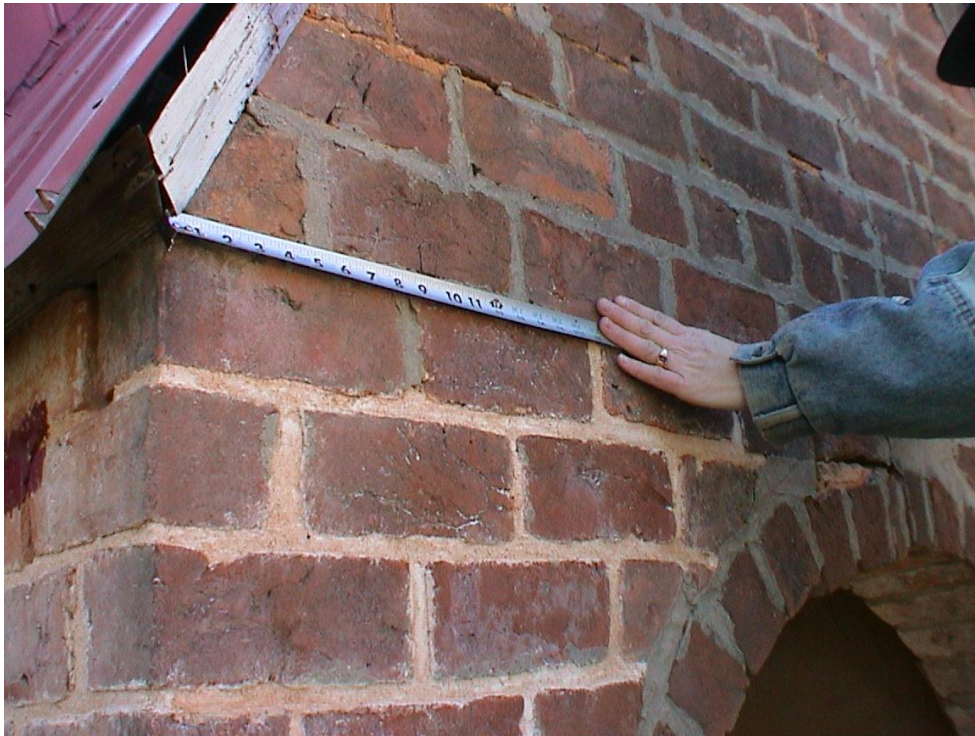
Figure 53

Front and sides

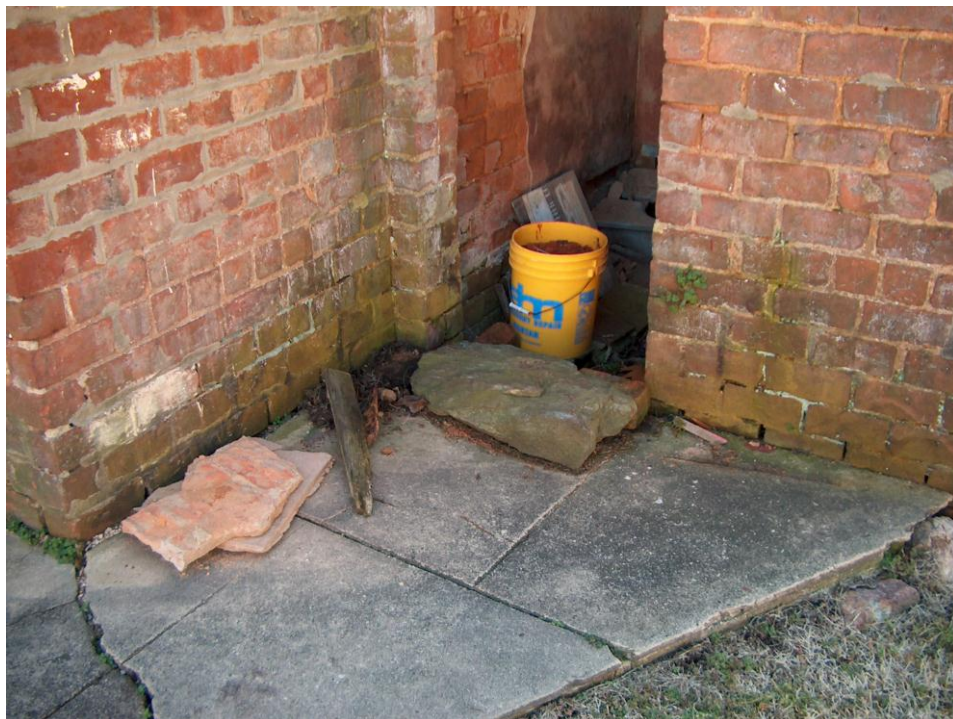
Figure 64
(Repointed)
